Resolving wired clock correction line issues with resistor packs

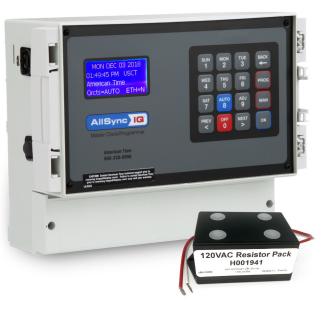
If some or all of the secondary clocks are replaced with a more efficient model, such as our AllSync Plus clocks, the decrease in resistance can cause these problems to become apparent. Typically, this appears in the form of the clocks constantly being in correction mode; because the correction line normally does not have power outside of the correction period, any excessive voltage present on this line can result in constant correction rather than normal operation.

Similar issues can occur if the power coming into the system controller is greater than normal or if the correction line is picking up transient voltage elsewhere on the circuit.

The resistor pack provides additional resistance, ensuring the only voltage coming through the correction line is the appropriate amount during the correction period. Available for both 110/120V and 24V systems and compatible with both the current AllSync IQ wired system or most legacy three-wire systems, the resistor pack can be wired into the circuit as shown at any location in the system.
